FEBRUARY 2021 | CASE STUDY

# We Energies Deploys Remote Monitoring to Keep an Eye on Transformer Bushings

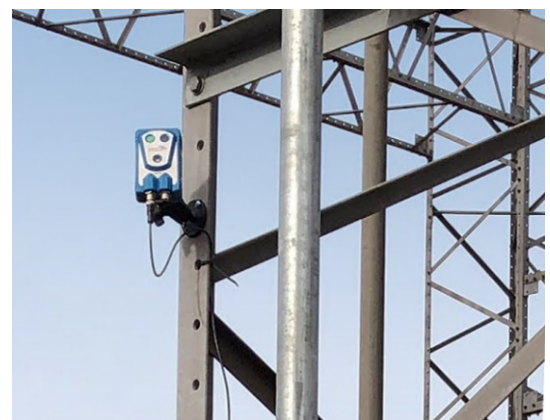
*Figure 1 – IM500 thermal plus visual sensor module can be installed close to high power.*

The IM500 is a programmable IoT module that scans key points on critical assets and doesn't require an outage to install it. The IM500 includes a thermal sensor and adds an additional visual sensor to provide the user a dual view of the asset. With built in cellular connectivity and low power requirements, the IM500 is easy to install and is up and running in minutes. It has a solar power option and connects automatically to the Systems With Intelligence cloud that stores and processes the collected temperature data. The IM500 has thermal analytics designed for electric power applications allowing comparative measurements on 3-phase systems and automated alarms to notify operators when temperatures exceed the defined limits.

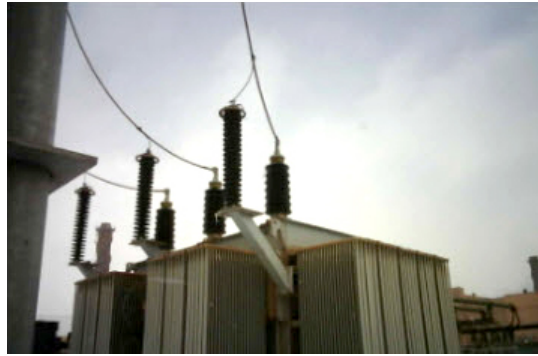
**Figure 3** - Visual image of the transformer recorded with the IM500 daily snapshot.

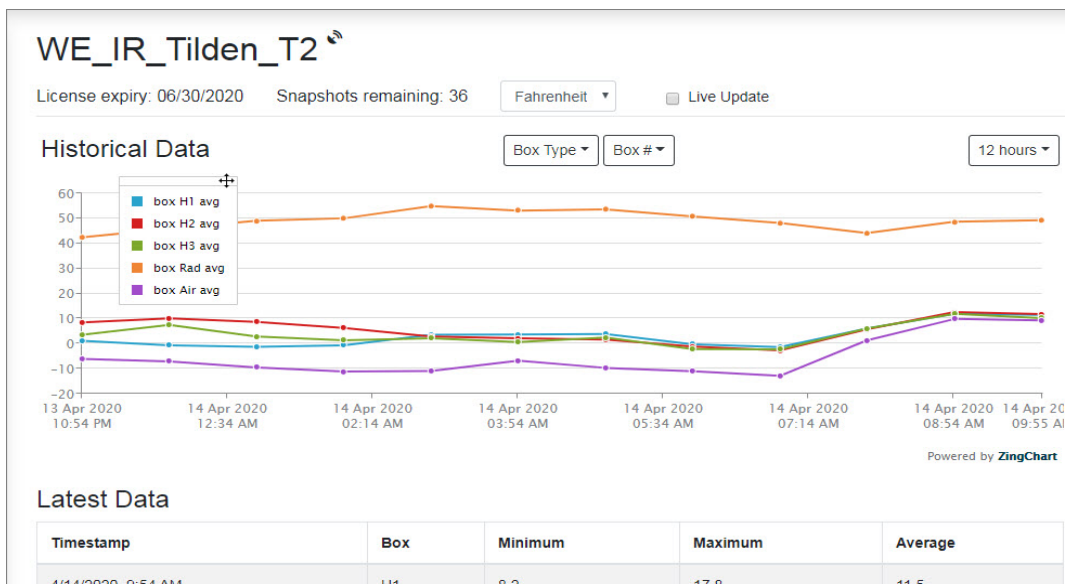
**Figure 4** - Comprehensive dashboard provides temperature graphing, alarms, and visualization information.

We Energies was able to monitor the problem bushing and document the condition so the customer could schedule an outage to perform the maintenance. Over the course of the monitor period the divergent temperature of the problem bushing was graphed, and the system generated alarms on two occasion when the differential temperature reached exceeded the set threshold.
